AFFDL-TR-79-3118  
Volume III

DURABILITY METHODS DEVELOPMENT  
VOLUME III  
STRUCTURAL DURABILITY SURVEY:  
STATE-OF-THE-ART ASSESSMENT

B. J. PENDLEY  
S. P. HENSLEE  
S. D. MANNING  
GENERAL DYNAMICS CORPORATION  
STRUCTURAL AND DESIGN DEPARTMENT  
FORT WORTH DIVISION  
FORT WORTH, TEXAS

TECHNICAL REPORT AFFDL-TR-79-3118, VOL. III

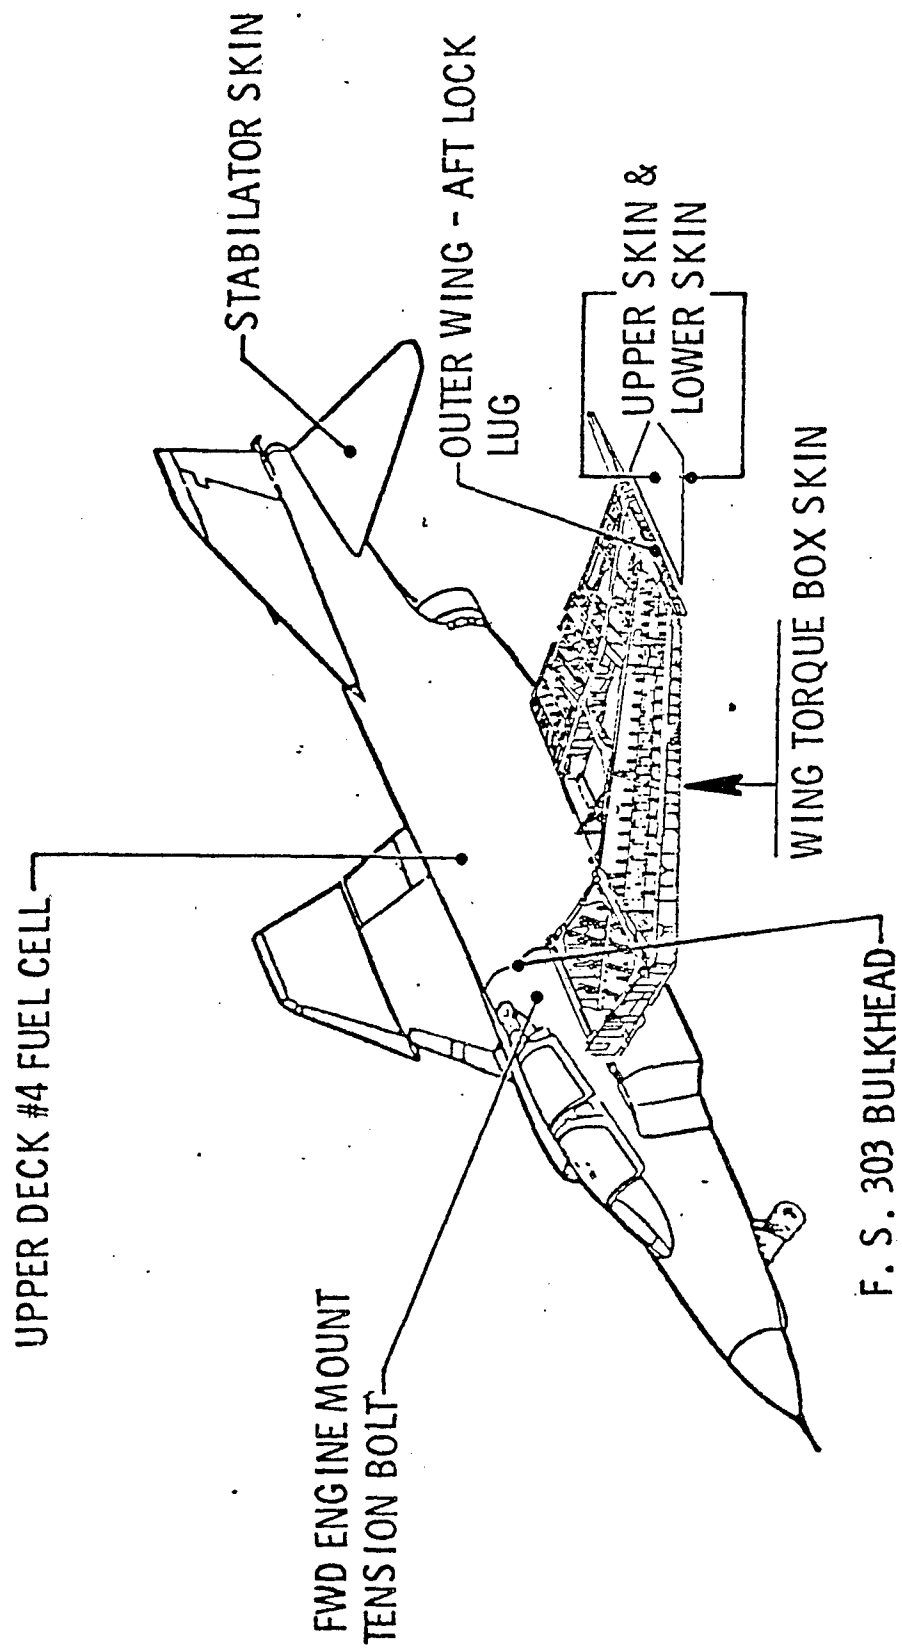
FIGURE 7 F-4 Significant Service Failures

Significant test and service failures are summarized in Figures 6 and 7, respectively. Service failures attributed to stress corrosion are shown in Figure 8.

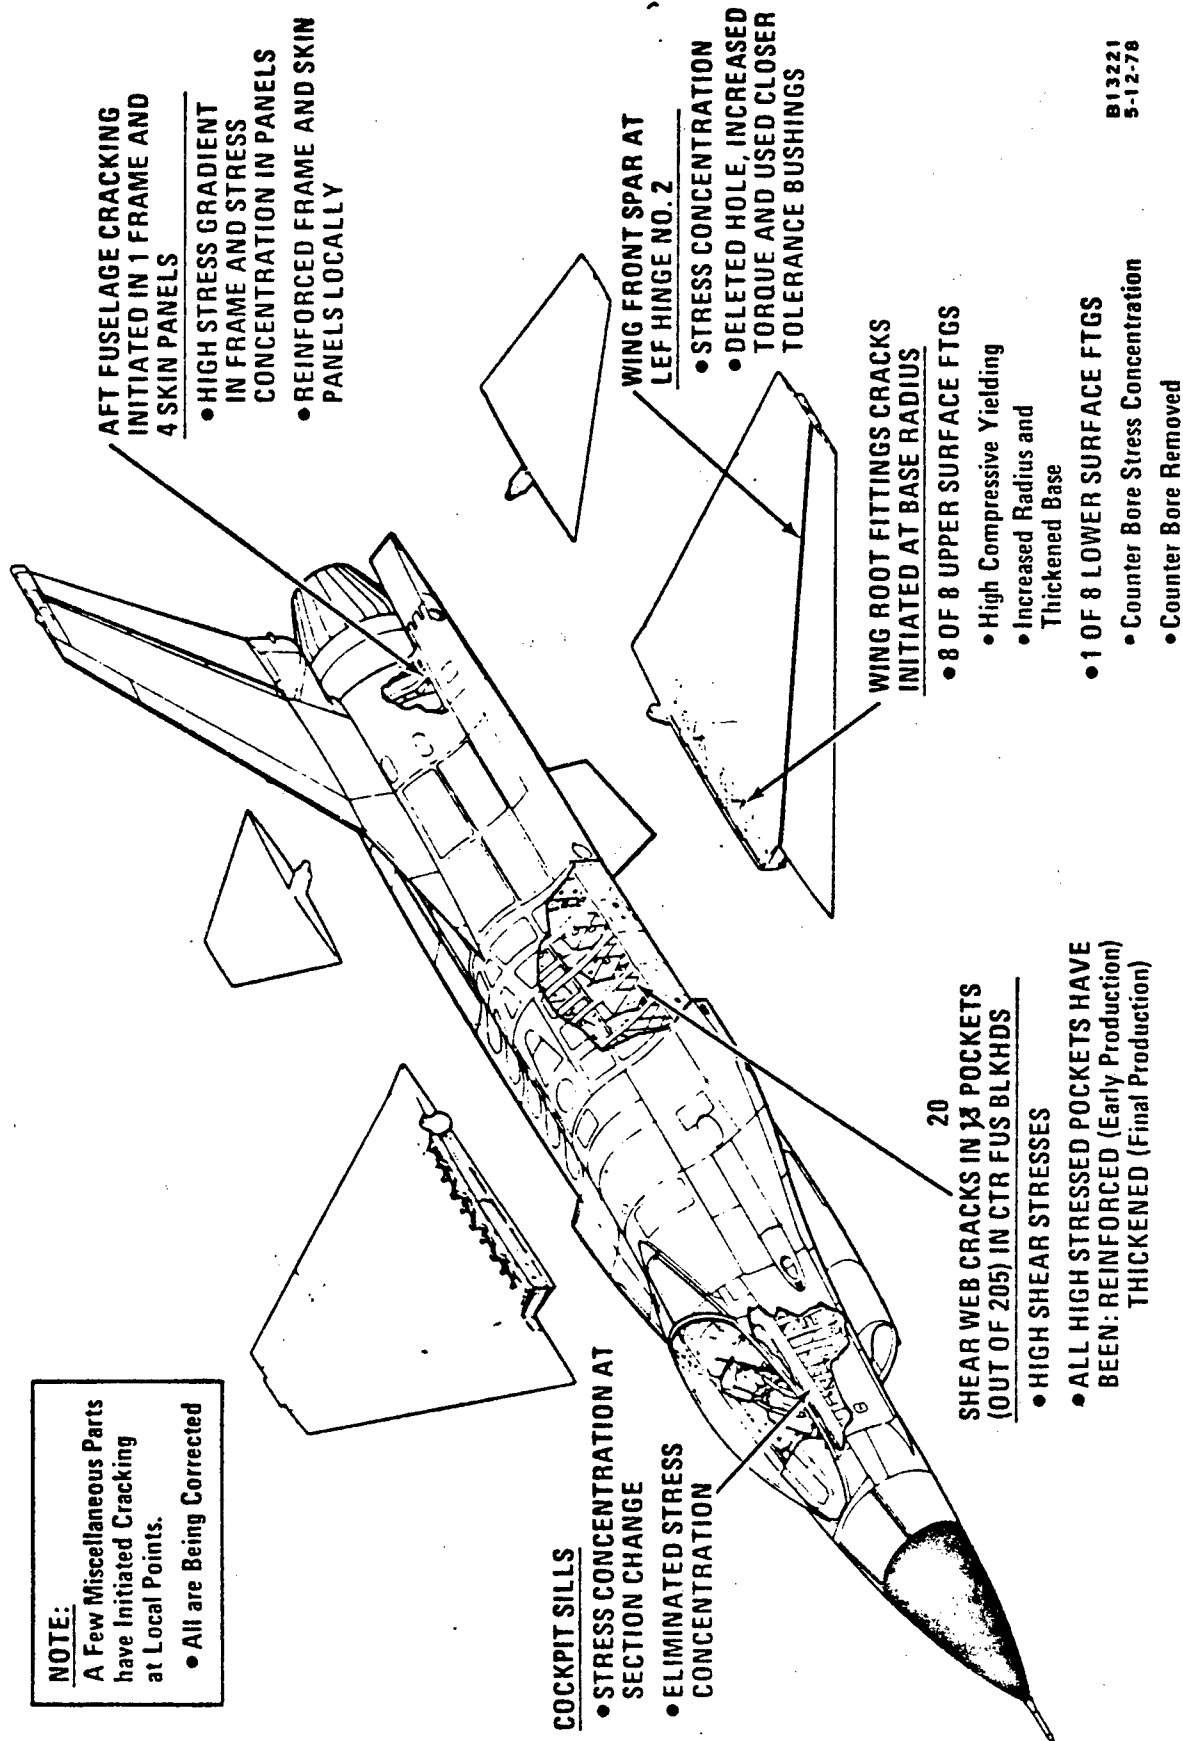
FIGURE 17 F-16 Durability Test Results at 8000 Hours Including  
8000 Hour Update

A full scale durability test program was conducted for the F-16 airframe. The airframe was tested to two service lives (8000 hours each) followed by a teardown inspection. Results of the two 8000 hour tests are shown in Figures 16 through 20. Teardown inspection results are shown in Appendix B.

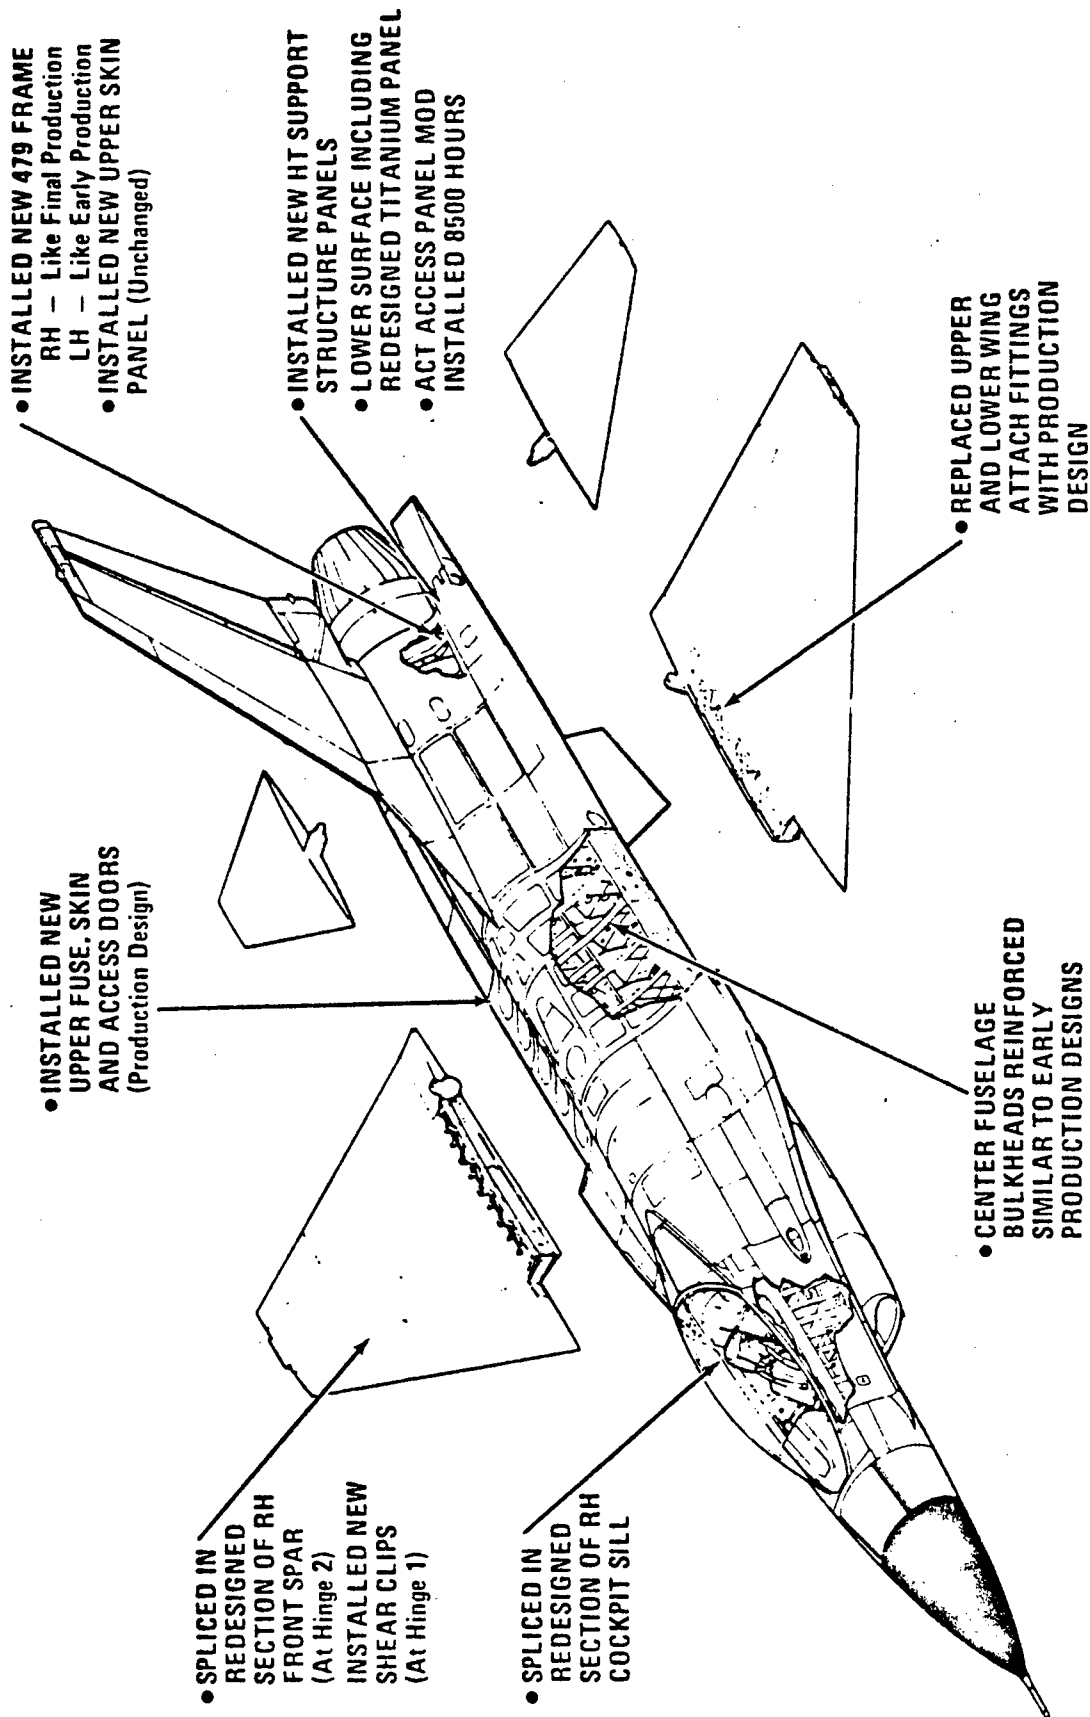
FIGURE 18 Modifications To Test Article - 8000 Hours

NOTE: All Parts Experiencing  
Cracking Were Redesigned  
for Production Con-  
figuration.

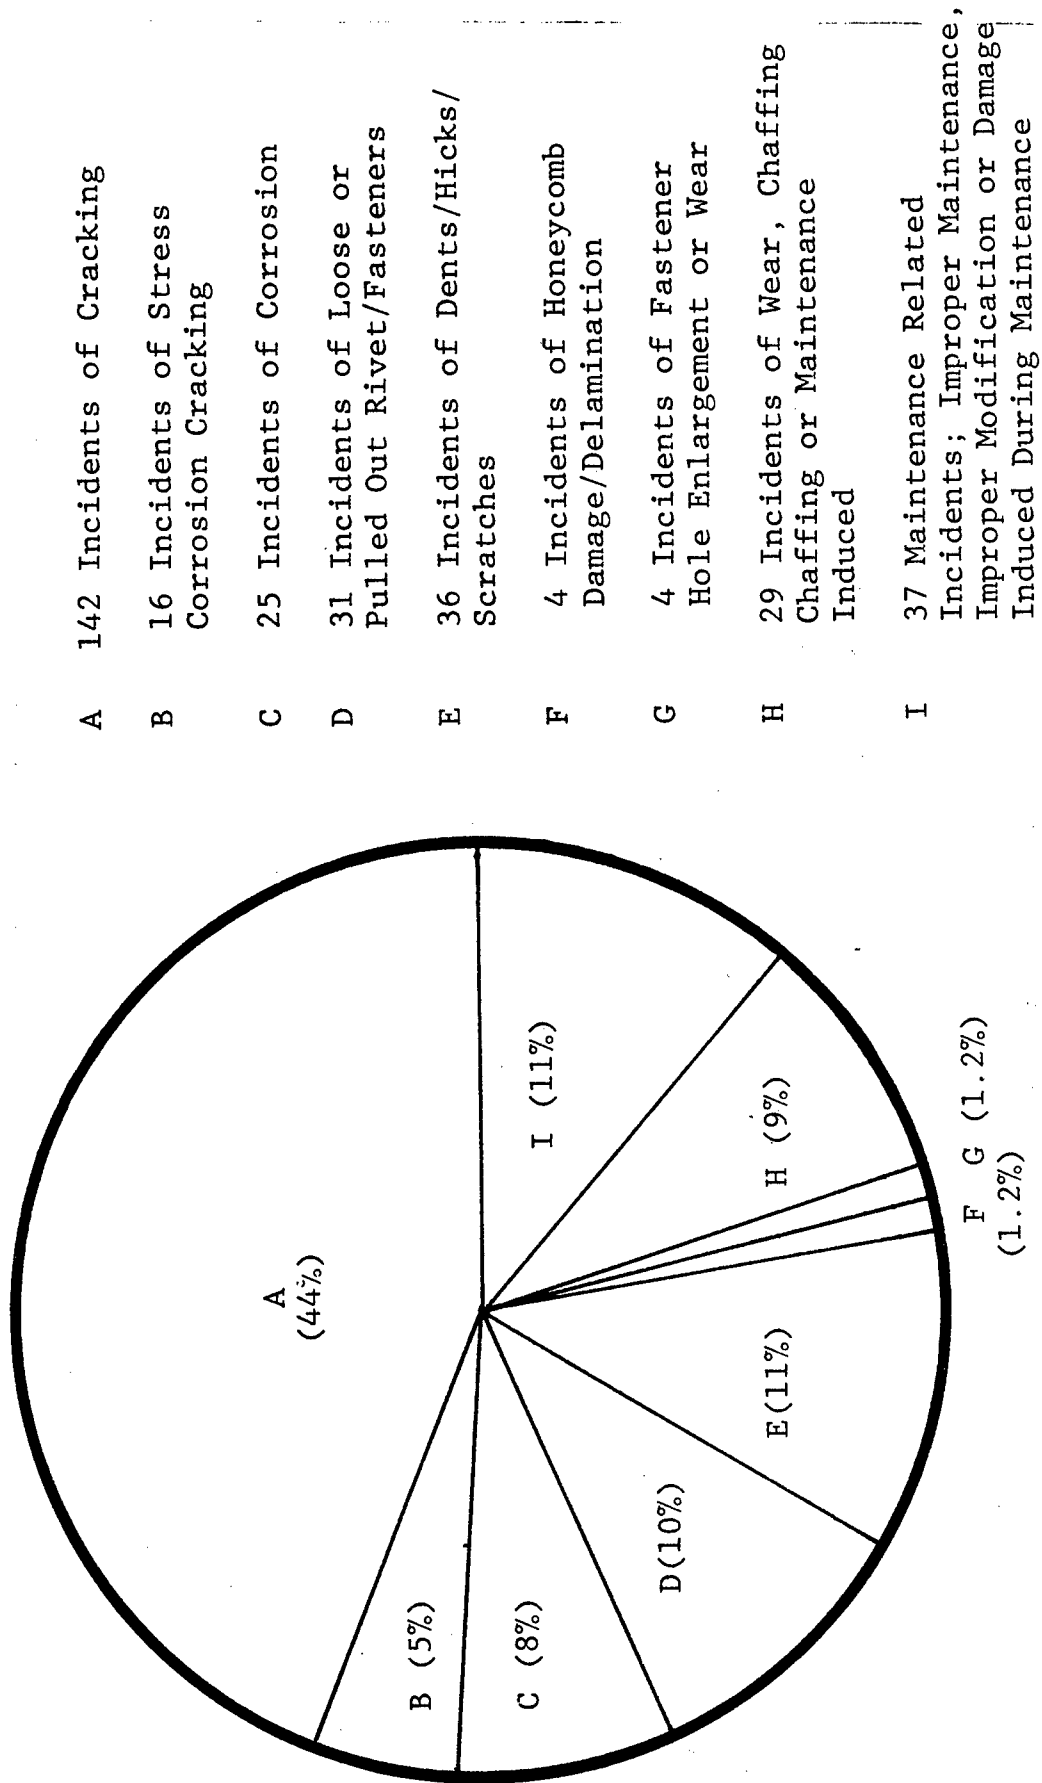
FIGURE 21 T-39A Analytical Condition Inspection  
(3 Aircraft Surveyed)

Figure 21 ranks the results in percentage by number of occurrences for the composite findings.

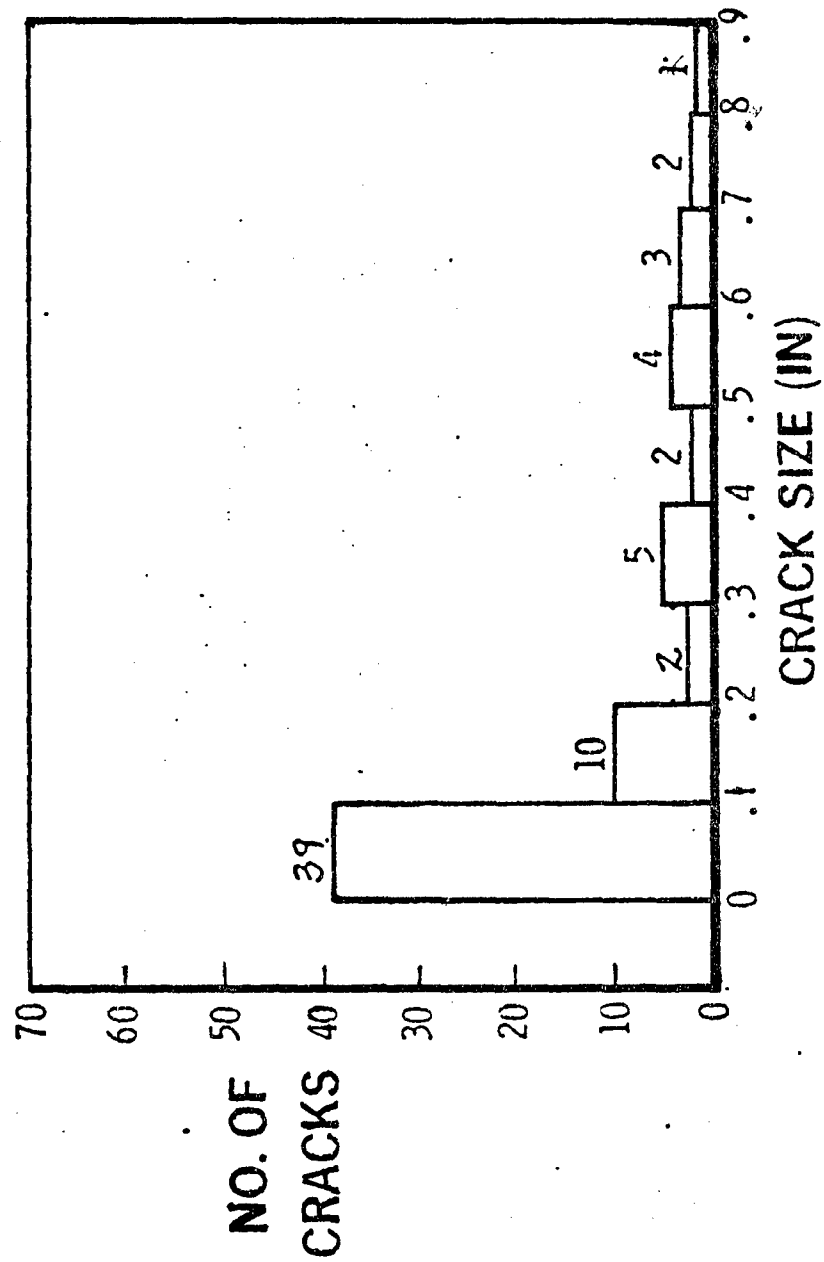
FIGURE 24 Histogram of Wing Crack Sizes  
 (Source: T-39D S.L.E.P. Wing  
 Teardown Report NA-77-595-1)

Figure 24 presents a histogram of the crack sizes recorded from the above L/R wing teardown inspection as documented in Reference 3, NA-77-599-1.

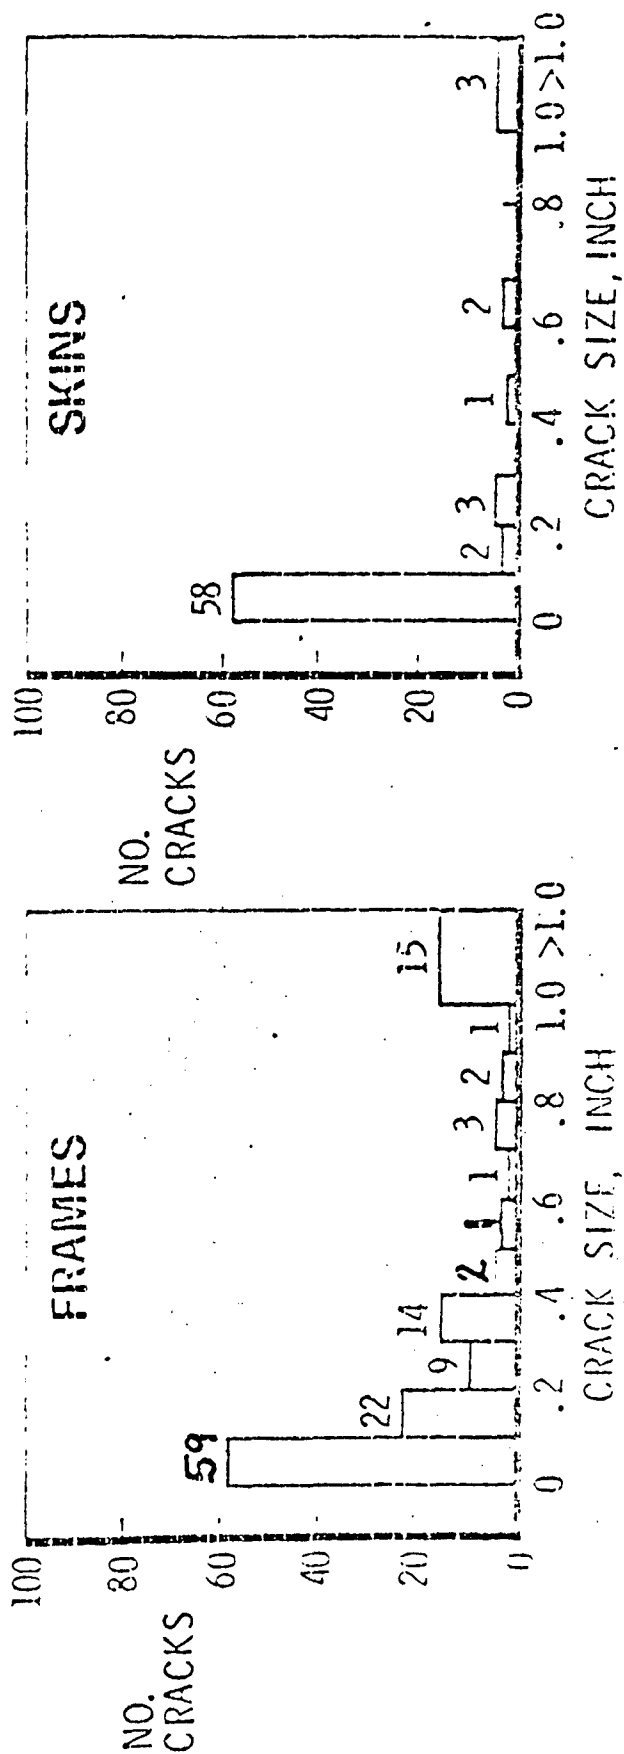
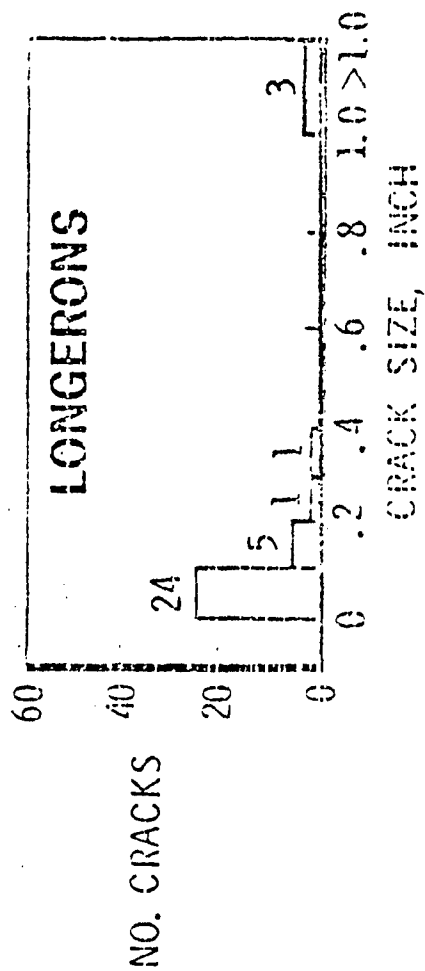
FIGURE 25 Histogram of Fuselage Crack Sizes  
(Source NA-265-40 Fuselage  
Teardown Report NA-77-595-2)

A teardown inspection was conducted on an NA-265-40 Sabreliner fuselage that had been subjected to a block type spectrum of fuselage bending loads for an equivalent 90,000 flight hours including a total of 43,000 pressurization cycles. The teardown was concentrated in the pressurized cabin area but also included the vertical stabilizer rear beam and engine pylon attach fittings. Also included in the teardown were the major longerons, wing attach frames and fittings, and the windshield support beam. Details of this teardown are given in Reference 3, NA-77-599-1.

A histogram of the fuselage crack sizes is shown in Figure 25 for the frames, skins and longerons. Figure 26 presents the vertical stabilizer crack size distribution.

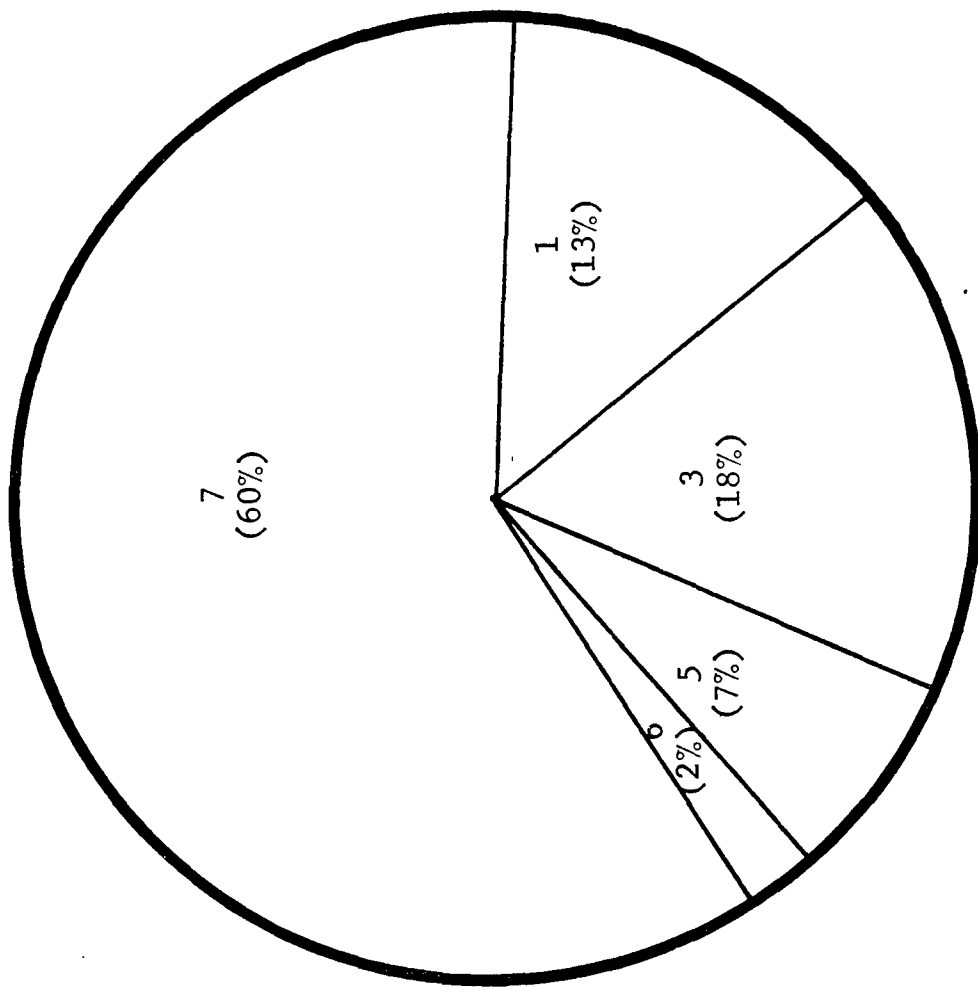
FIGURE 30 FB-111 Airframe Test Program Summary

During the cyclic test program there were 45 recorded test incidents. A breakdown of these results is shown in Figure 30.

45 TEST INCIDENTS  
(40000 Equivalent Flight Hours)

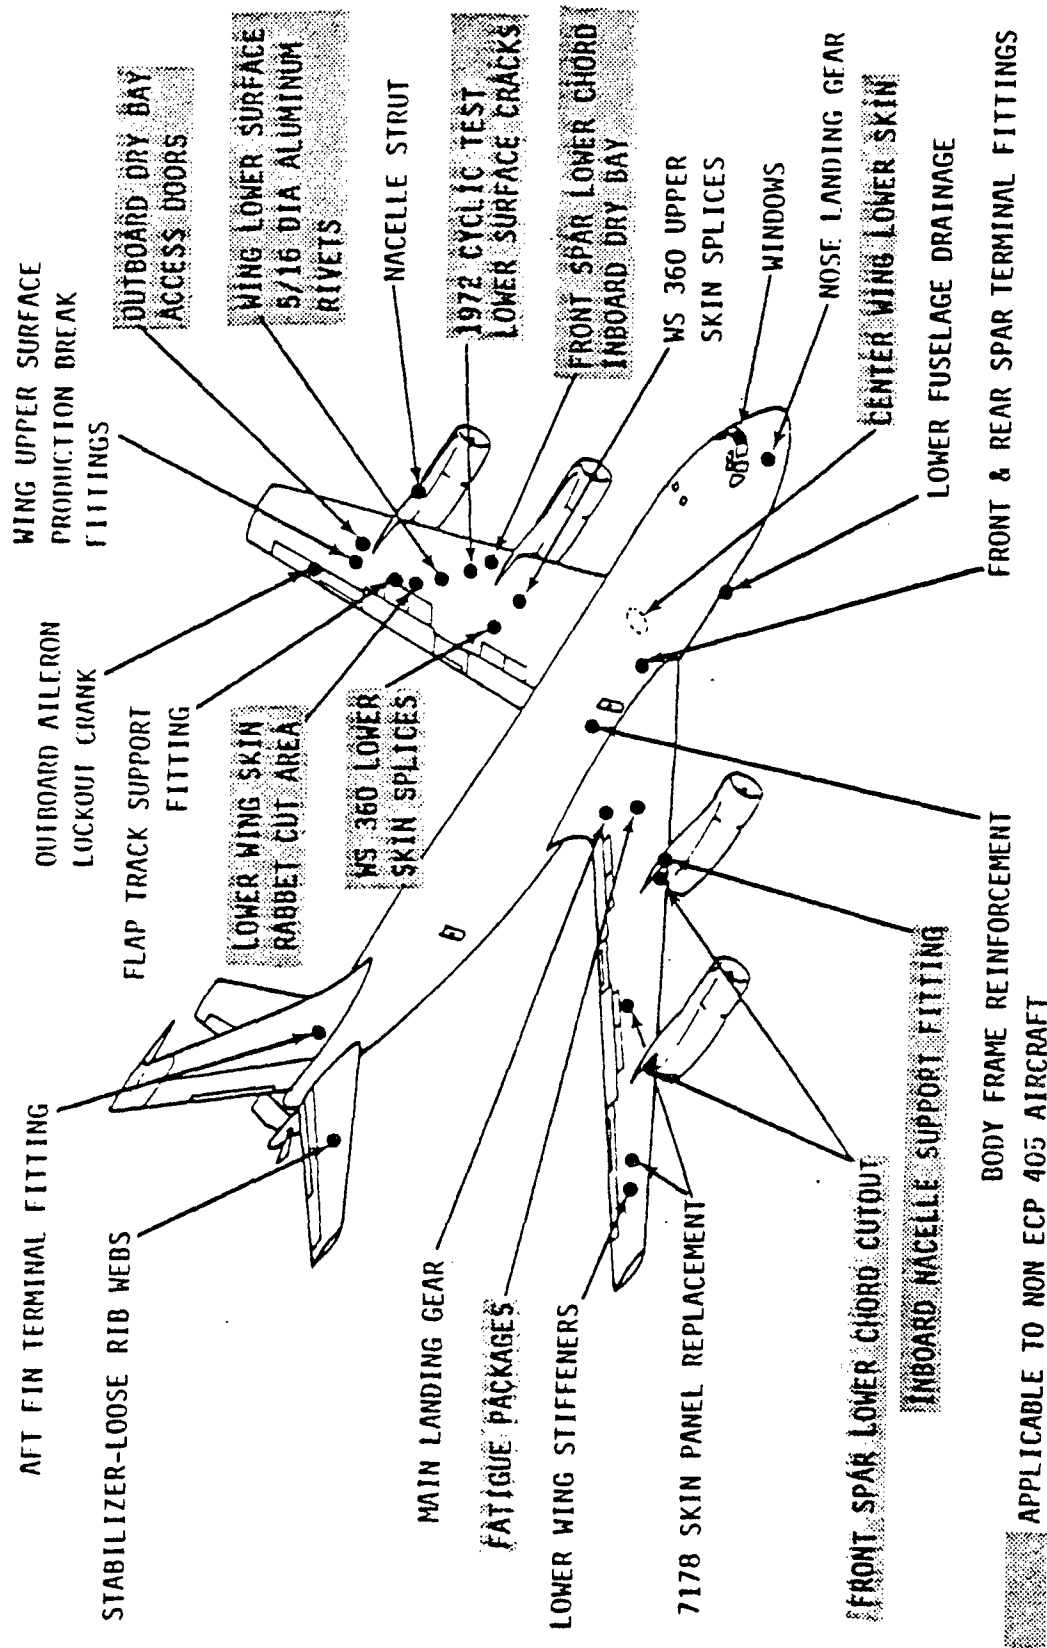
FIGURE 40 C/KC-135 Problem Areas

Service experience is continually monitored and updated on the 707 and C/KC-135 fleet to identify durability problem areas that affect structural integrity. The known fleet problem areas relating to fatigue, stress corrosion, corrosion and miscellaneous items that have been identified from 707 and C/KC-135 fleet experiences are shown on Figure 40 and listed in Table 18. Figure 41 presents a cumulative plot of wing fatigue crack locations versus calendar year and Figure 43 shows the cumulative number of cracks at these locations versus calendar year.

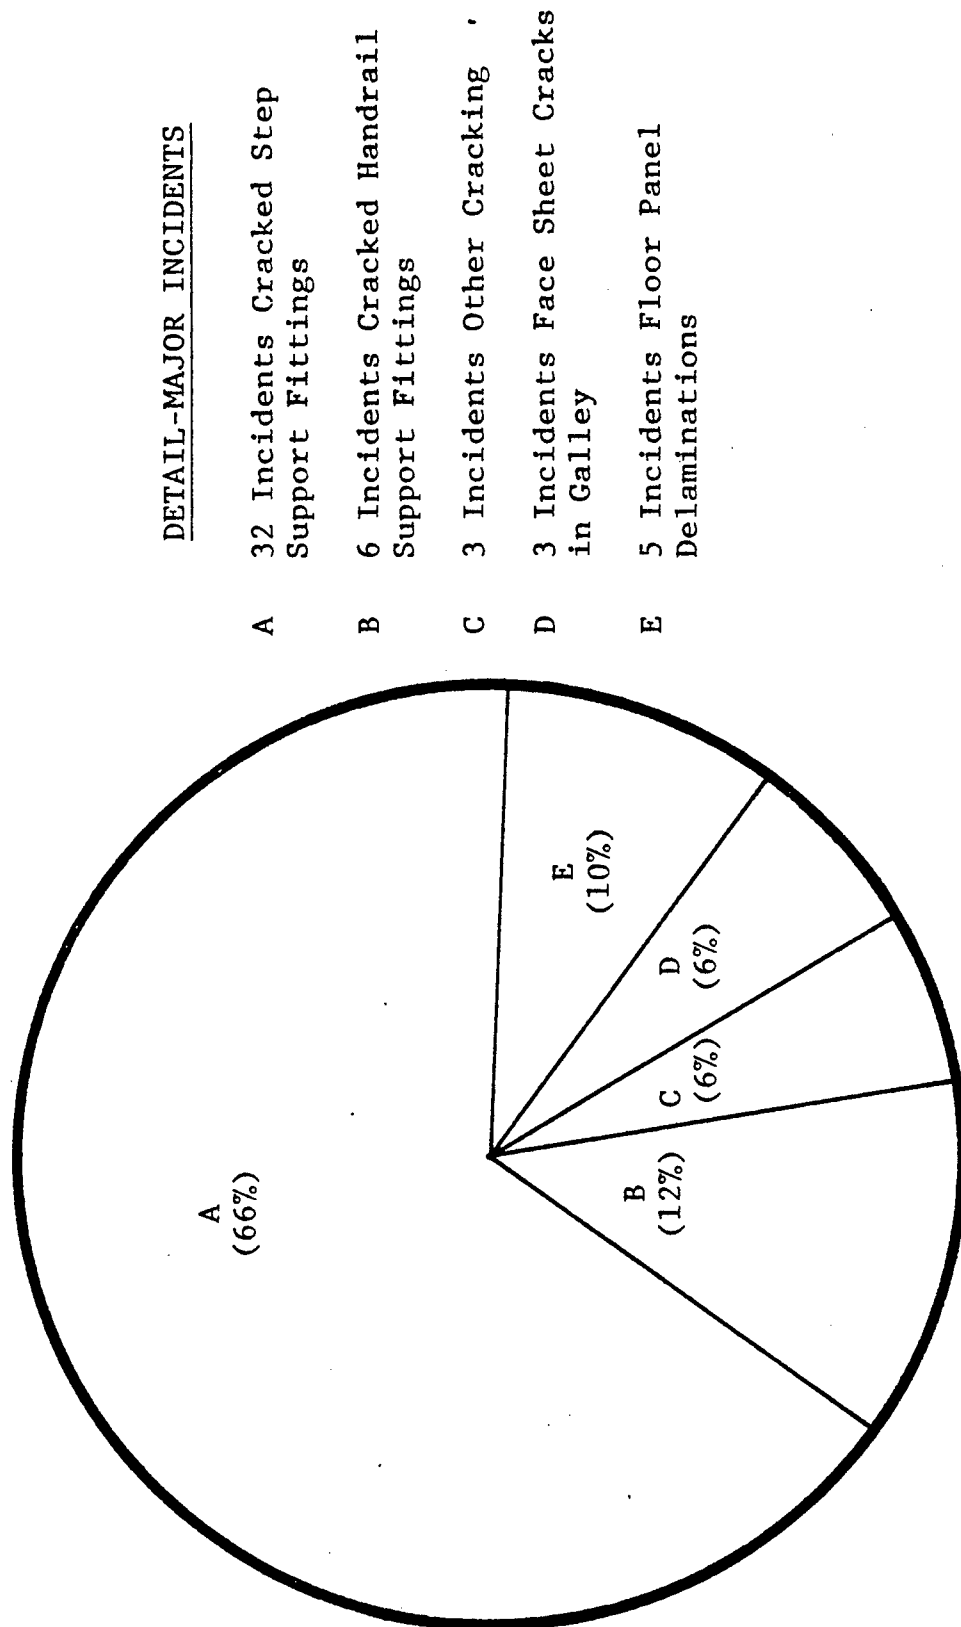
FIGURE 46 C-5A ACI Summary For CY 1976 (Major Incidents)

Analytical condition inspections (ACI) have also been used to monitor the durability of the C-5A structure. These data for Calendar Years 1976 and 1977 are included in Figures 46 through 50.

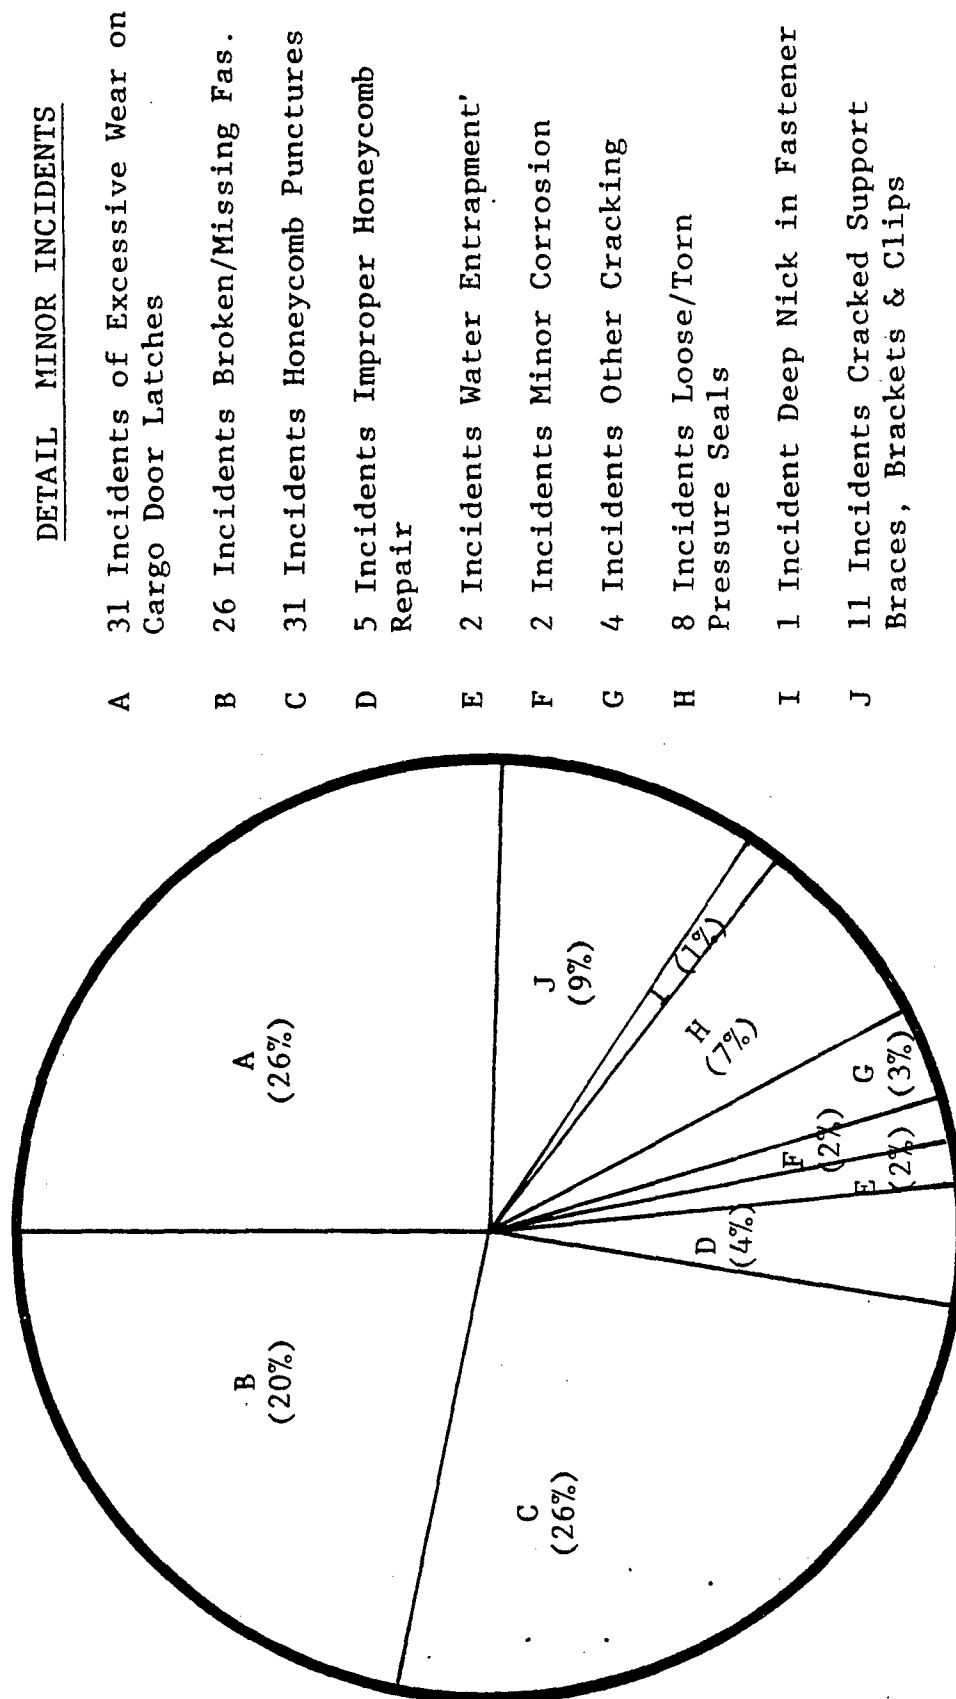
FIGURE 47 C-5A ACI Summary For CY 1976 (Minor Incidents)

121 MINOR INCIDENTS  
(FROM INSPECTION OF 10 A/C)

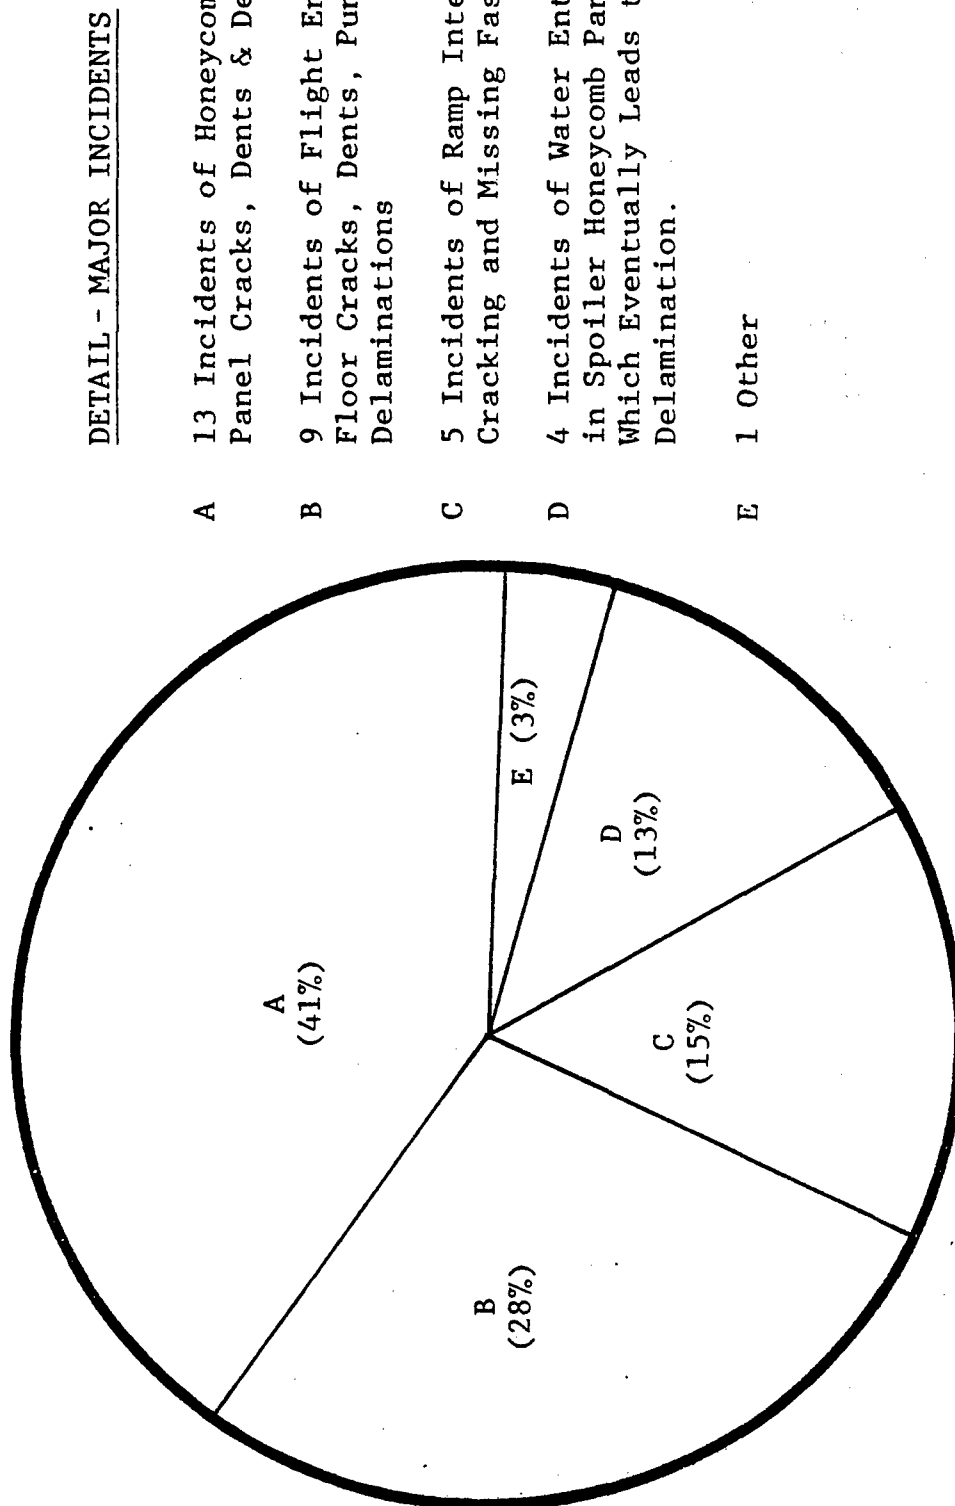
FIGURE 49 C-5A ACI Summary For FY 1977 (Major Incidents)

32 MAJOR INCIDENTS  
(FROM INSPECTIONS OF 6 A/C)

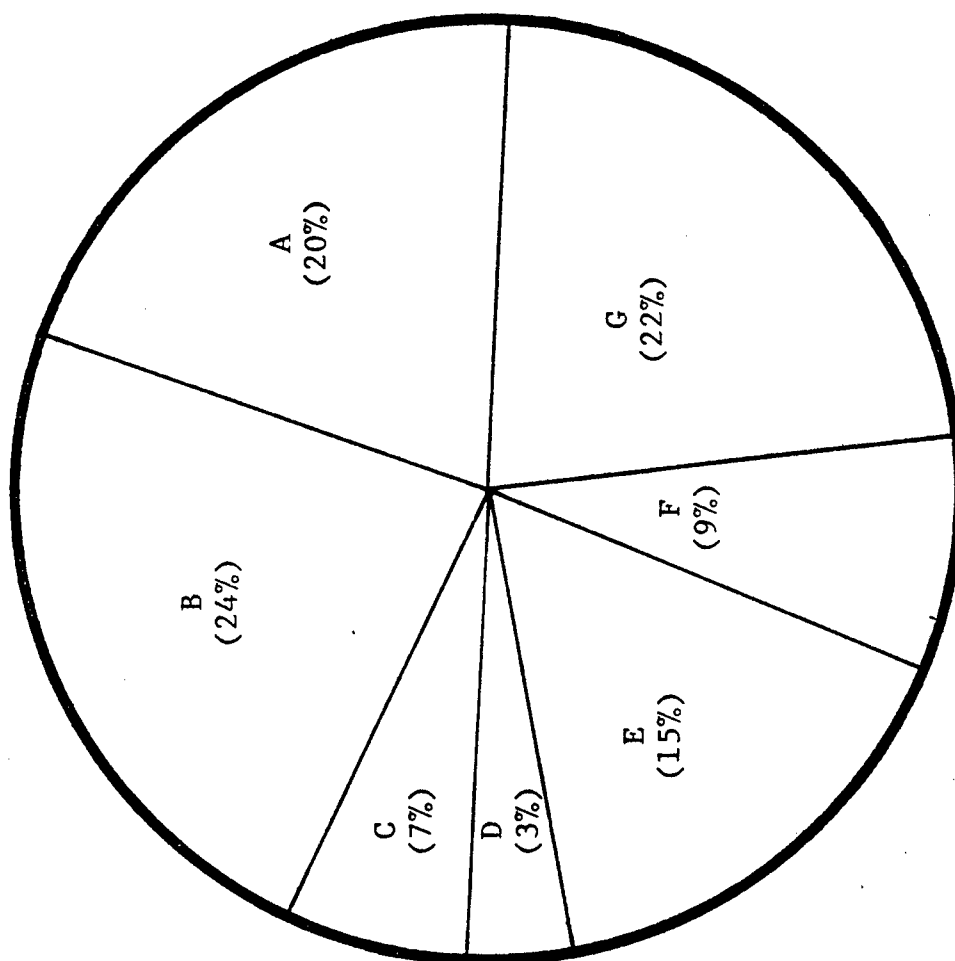
FIGURE 50 C-5A ACI Summary For FY 1977 (Minor Incidents)

59 MINOR INCIDENTS  
(FROM INSPECTION OF 6 A/C)

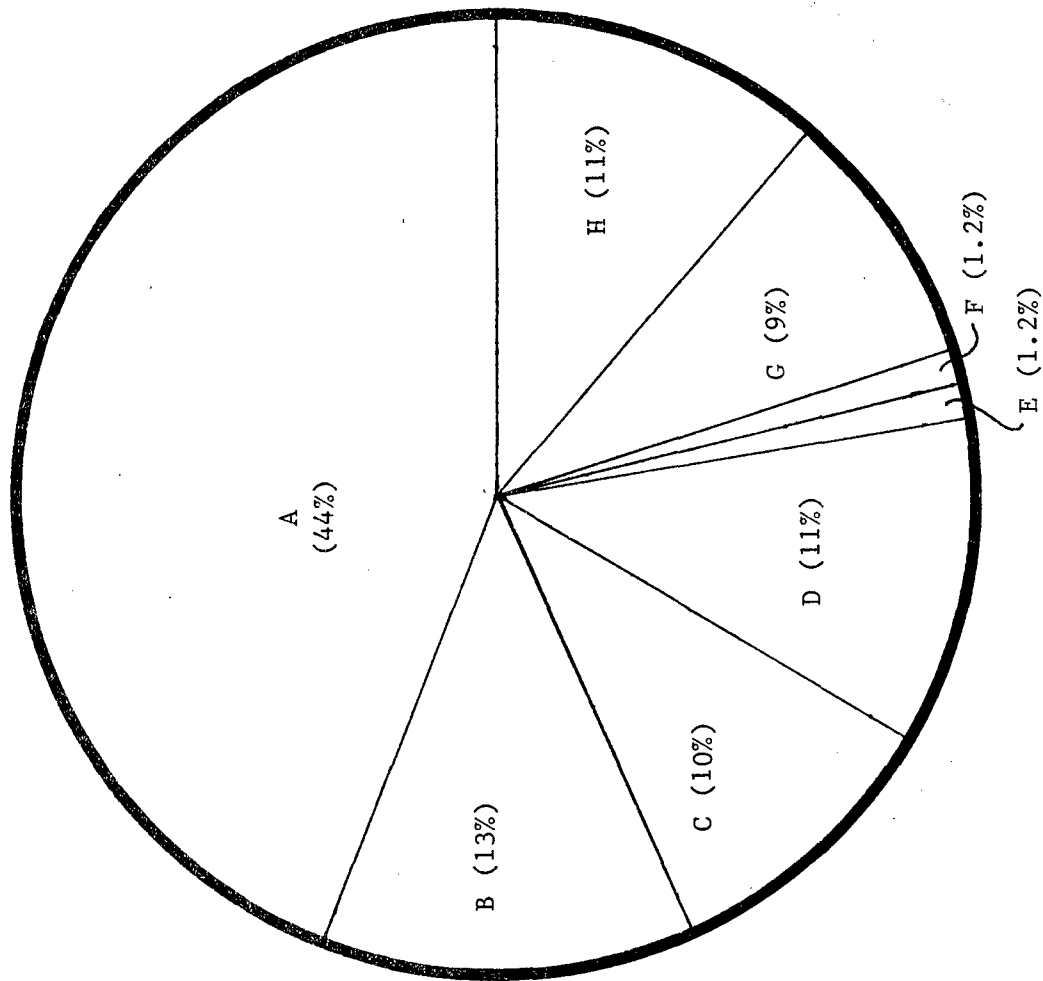
Figure 51 T-39A Analytical Condition Inspection (3 Aircraft Surveyed)

The T-39A trainer, Figure 51, provided some very interesting results. This particular ACI was very comprehensive, perhaps due to the age of this system. Obviously cracking was the predominate occurrence, but of special interest was the number of maintenance-related incidents. The incidents, which are not mentioned in all ACIs, are the results of careless induced maintenance. Those incidents include abuse of "no-step" areas or dropping of tools on sensitive areas. Also included are incidents of improperly performed maintenance, such as double or misdrilled holes, and other damage associated with the drilling of holes. It should be noted that although the amount of cracking shown may seem excessive, when considered relative to the time in service this number may approach mean values.

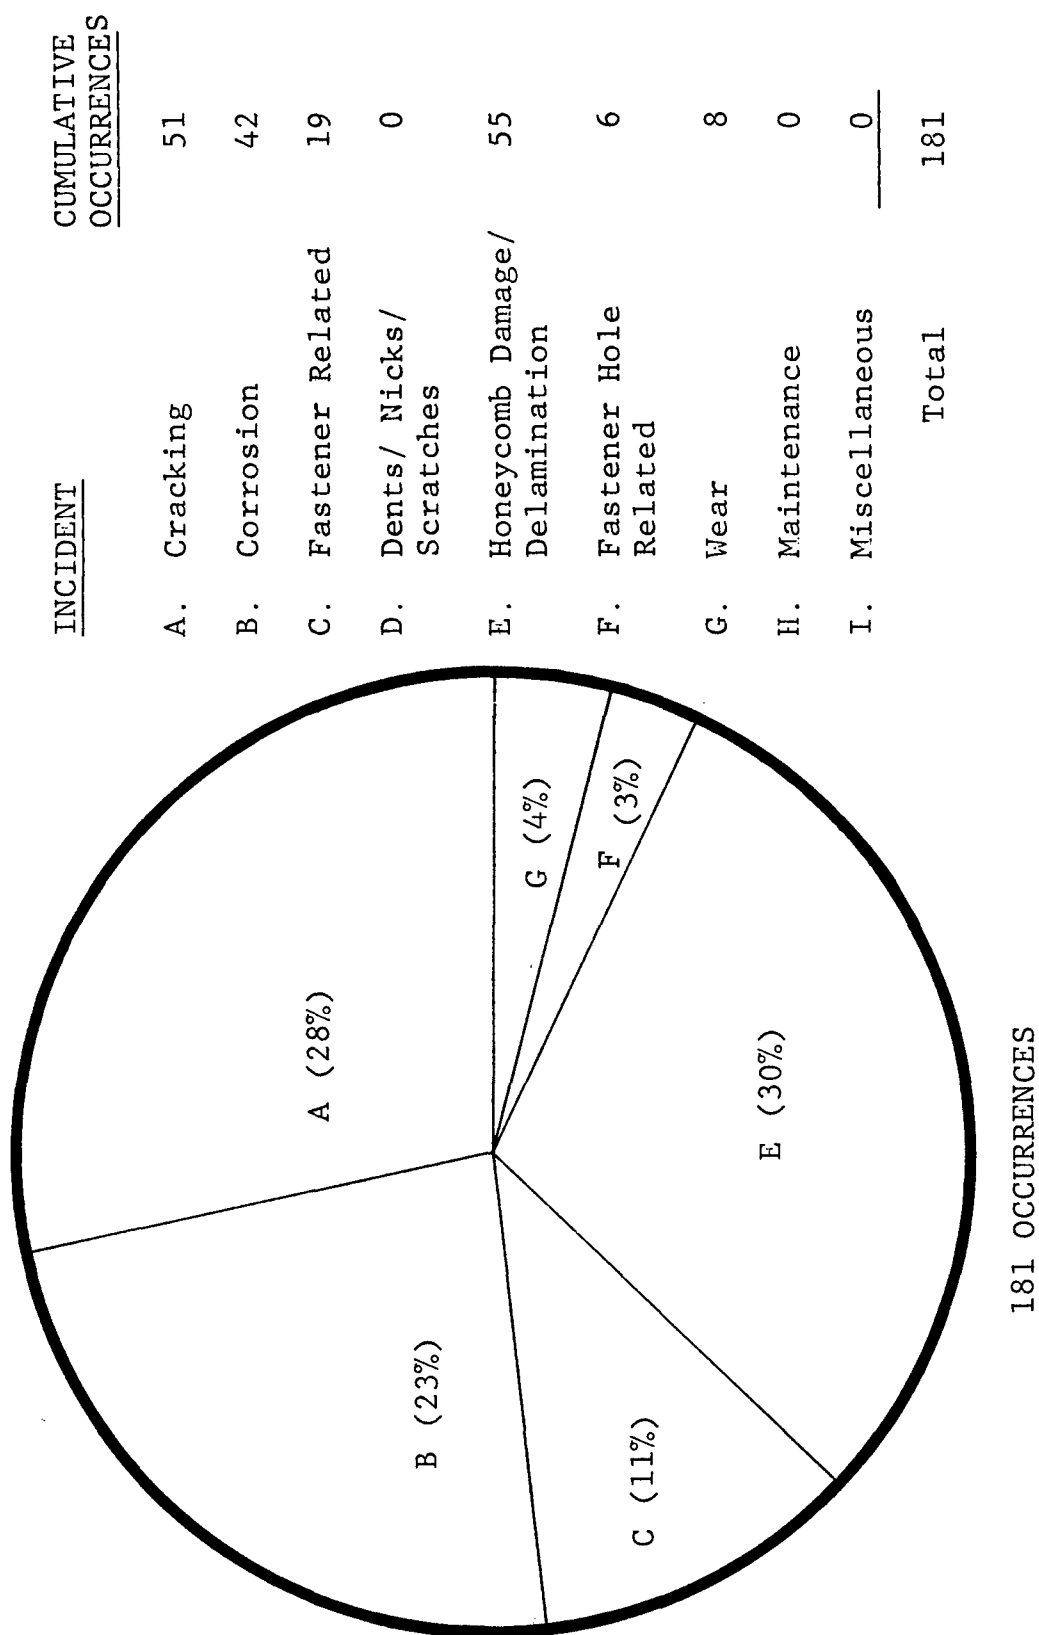
Figure 52 F-4C/D/E and RF-4C Analytical Condition Inspection (44 Aircraft Surveyed).

The ACI summary for the F-4C/D/E and RF-4C is shown in Figure 52. This ACI was conducted during CY77 and represents a survey of 44 aircraft. These aircraft have seen lengths of service time that vary from one to fourteen years. The mean service lives are listed below:

As shown in Figure 52 there are several incidents worthy of note. Occurrences of cracking, corrosion, fastener related incidents, fastener-hole-related incidents, and wear are relatively normal. On the other hand the amount of honeycomb damage is abnormally high. There are no reported occurrences of
